**Flood Control Project Maintenance  
Levee Inspections**

**Fall 2015 Levee Maintenance Deficiency Summary Report**

**San Joaquin River Basin**

**Reclamation District No. 2089 Stark**

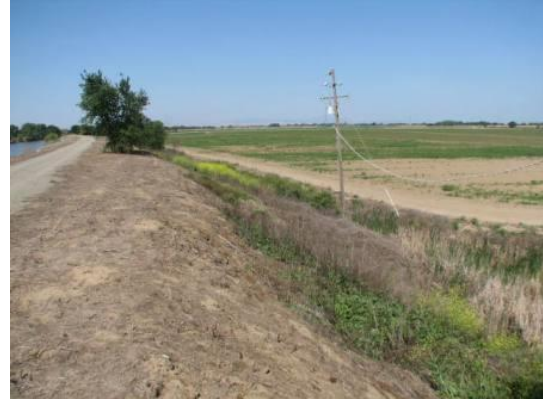
Photo 1 of 1 : FA\_2015\_RD2089\_316\_9\_20150910\_00006.jpg

LM Start	0.00	Rating **	M	Issue No.	9
LM End	0.38	Issue Type +	En	Location *	LS
Category	Earthen Levee			GPS Latitude/Longitude	
				Start	End
Item	Encroachments			37.811681 °	37.809755 °
				-121.384930 °	-121.391520 °
DWR ID	DWR_RD2089_01_s_2012_9				
Action/Comments					
Ditch					
Inspector Comments: 05/24/2011 Photo added of Ag ditch.

05/24/2011 Ditch flows parallel with the utility line shown in the photo.

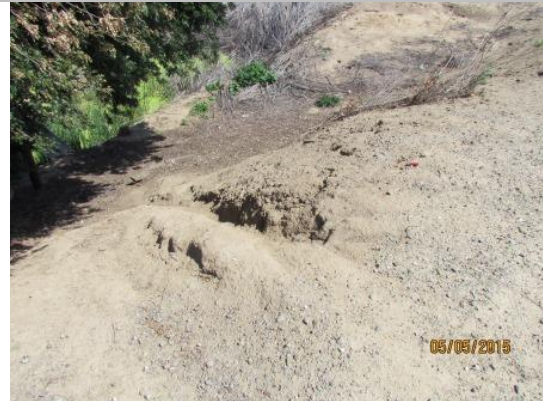
Photo 1 of 1 : FA\_2015\_RD2089\_316\_1\_20150910\_00001.jpg

LM Start	0.04	Rating **	M	Issue No.	1
LM End	0.04	Issue Type +	Ma	Location *	LS
Category	Earthen Levee			GPS Latitude/Longitude	
				Start	End
Item	Encroachments			37.811474 °	37.811474 °
				-121.385573 °	-121.385573 °
DWR ID	DWR_RD2089_01_s_2012_1				
Action/Comments					
Stairway					
Inspector Comments: Steps have been cut into the levee slope, this could become an erosion point, please fill and compact.

View of the stairs eroding into the landside levee slope.

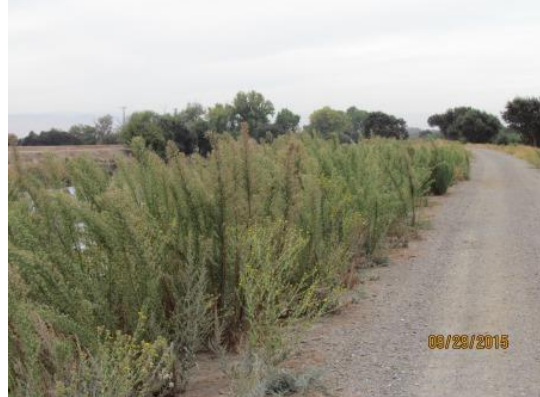
Photo 1 of 1 : FA\_2015\_RD2089\_316\_22\_20151005\_00037.jpg

LM Start	0.06	Rating **	M	Issue No.	22
LM End	0.10	Issue Type +	Ma	Location *	WS
Category	Earthen Levee			GPS Latitude/Longitude	
				Start	End
Item	Vegetation			37.811381 °	37.811201 °
				-121.386027 °	-121.386722 °
DWR ID	DWR_RD2089_01_f_2015_22				
Action/Comments					
Control annual grass and weeds on the levee slopes and easements.

View of the tall vegetation obstructing visibility of the waterside levee slope.

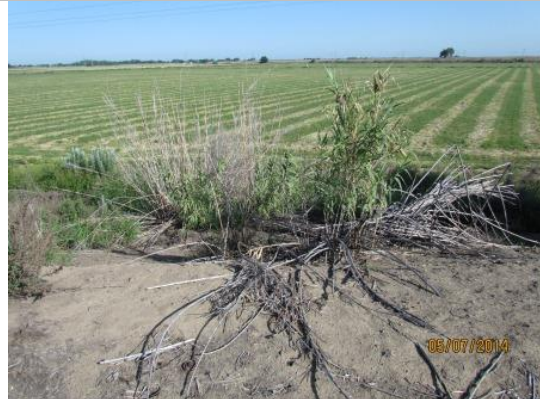
Photo 1 of 1 : FA\_2015\_RD2089\_316\_940\_20150910\_00030.jpg

LM Start	0.24	Rating **	M	Issue No.	940
LM End	0.24	Issue Type +	Ma	Location *	LS
Category	Earthen Levee			GPS Latitude/Longitude	
				Start	End
Item	Vegetation			37.810412 °	37.810412 °
				-121.389115 °	-121.389115 °
DWR ID	DWR_RD2089_01_s_2012_940				
Action/Comments					
Remove the wild growth other than native grasses from the levee slopes. Inspector Comments: Arundo has been trimmed back from the crown but still remains as an obstruction to the slope and obstructs visibility, needs to be removed.

The LMA is actively trying to remove the vegetation on the landside levee slope and toe.

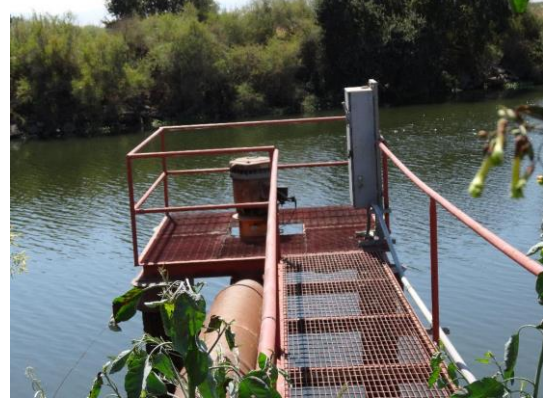
Photo 2 of 3 : UCIP\_FA\_2015\_2281.jpg

Inspector Comments: FS\_ID:21635  
 DS\_ID:23042  
 EP\_NO: 5641  
 FS\_HLM: 0.4614  
 Repair Type: Non-Urgent  
 Crossing Status: Found  
 UCIP Comments: - damaged siphon breaker.- most of the pipe on landside exposed on levee slope.  
 FIELD\_STRUCT\_DESC: 20-inch steel pipe and electric conduit through the levee, 5.8 feet below the crown, pump on pile structure in the stream. Siphon breaker on the landward slope. (App. No. 5641- Ted Stark)  
 FS Date: 09/12/2013

WS view: steel walkway, electric control box, and pump on steel piling structure in the channel.

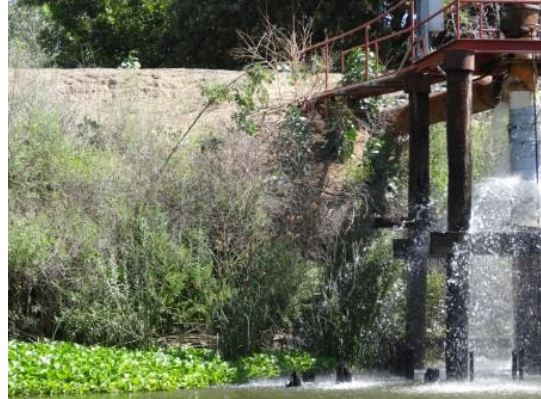
Photo 1 of 2 : SJR2015\_RD2089U01RM29.8\_8.jpg

LM Start	0.46	Rating **	M	Issue No.	5
LM End	0.46	Issue Type +	Ma	Location *	WS
Category	Supplemental			GPS Latitude/Longitude	
				Start	End
Item	DWR Erosion Survey			37.809394 °	37.809394 °
				-121.392791 °	-121.392791 °
DWR ID					
Action/Comments					
Inspector Comments: 06/25/2015: No significant change observed. 07/02/2014: No significant change observed. 08/13/2013: No significant change observed. 08/07/2012: The site has been visited by boat survey. No significant change observed 08/23/2011: The site shows loose material around the pipe crossing.

Close view of the site.

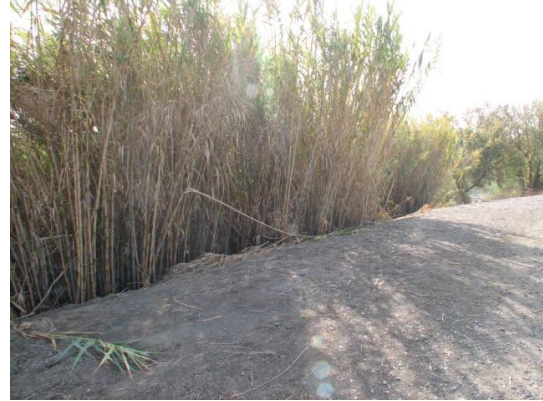
Photo 1 of 1 : FA\_2015\_RD2089\_316\_33\_20150910\_00019.jpg

LM Start	0.94	Rating **	M	Issue No.	33
LM End	0.94	Issue Type +	Ma	Location *	WS
Category	Earthen Levee			GPS Latitude/Longitude	
				Start	End
Item	Vegetation			37.806397 °	37.806397 °
				-121.397758 °	-121.397758 °
DWR ID	DWR_RD2089_01_s _ 2012_33				
Action/Comments					
Remove the wild growth other than native grasses from the levee slopes. Inspector Comments: Arundo on waterside impedes visibility and access to waterside slope.

11/10/2011 Arundo on upper 20' of waterside slope.

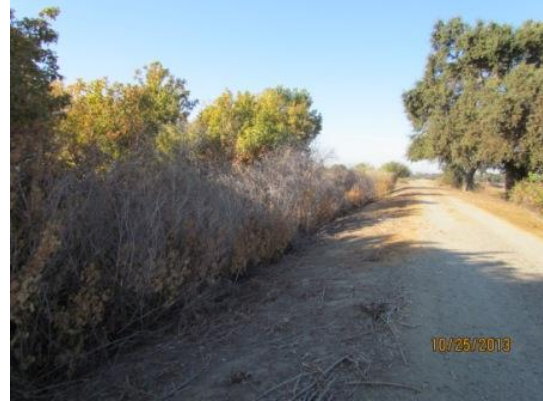
Photo 1 of 1 : FA\_2015\_RD2089\_316\_35\_20150910\_00020.jpg

LM Start	0.95	Rating **	M	Issue No.	35
LM End	1.01	Issue Type +	Ma	Location *	WS
Category	Earthen Levee			GPS Latitude/Longitude	
				Start	End
Item	Vegetation			37.806264 °	37.806083 °
				-121.397961 °	-121.398920 °
DWR ID	DWR_RD2089_01_s _ 2012_35				
Action/Comments					
Remove the wild growth other than native grasses from the levee slopes.

Thick vegetation on upper 20' of waterside slope obstructing visibility and access.

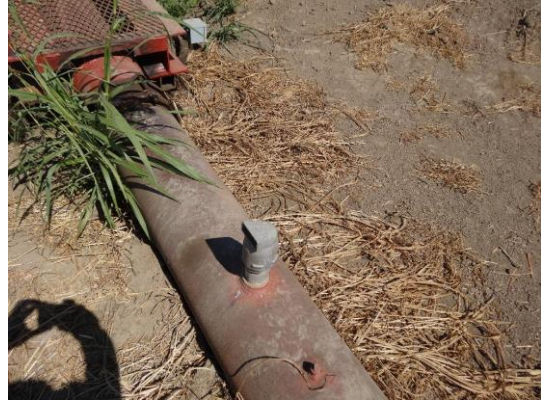
Photo 1 of 3 : UCIP\_FA\_2015\_2507.jpg

LS view: air vent on steel pipe near walkway at levee toe.

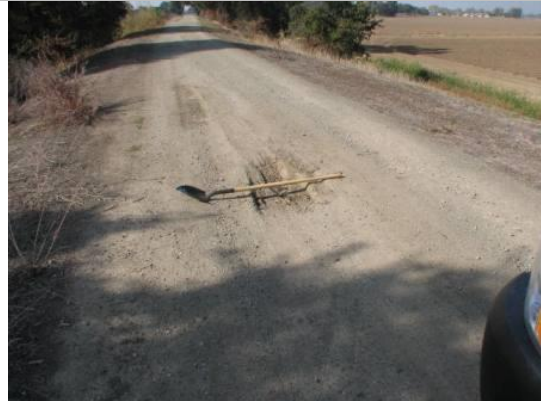
Photo 1 of 1 : FA\_2015\_RD2089\_316\_45\_20150910\_00025.jpg

LM Start	1.34	Rating **	M	Issue No.	45
LM End	1.34	Issue Type +	Ma	Location *	CR
Category	Earthen Levee			GPS Latitude/Longitude	
				Start	End
Item	Crown Surface / Depressions / Rutting			37.806128 °	37.806128 °
				-121.404890 °	-121.404890 °
DWR ID	DWR_RD2089_01_s _ 2012_45				
Action/Comments					
Add appropriate gravel or road base. Grade and compact. Inspector Comments: 11/10/2011 Depression needs to be filled.

11/10/2011 Roadway depression.

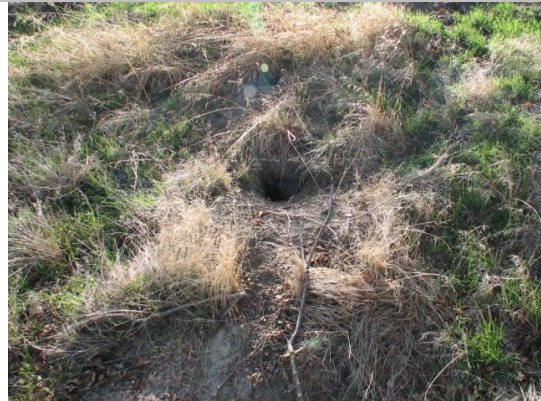
Photo 1 of 1 : FA\_2015\_RD2089\_316\_47\_20150910\_00027.jpg

LM Start	1.40	Rating **	M	Issue No.	47
LM End	1.40	Issue Type +	Ma	Location *	LS
Category	Earthen Levee			GPS Latitude/Longitude	
				Start	End
Item	Animal Control			37.806268 °	37.806268 °
				-121.405874 °	-121.405874 °
DWR ID	DWR_RD2089_01_s _ 2012_47				
Action/Comments					
No rodents visible, but rodent burrows visible; need to backfill and compact or grout burrows. Inspector Comments: 11/10/2011 No rodents visible, but active burrows are present.

11/10/2011 Active rodent burrow on landside slope.

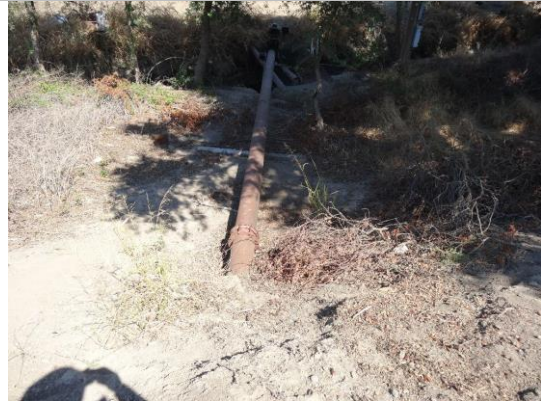
Photo 1 of 3 : UCIP\_FA\_2015\_1802.jpg

LS view: exposed steel pipe on levee slope.

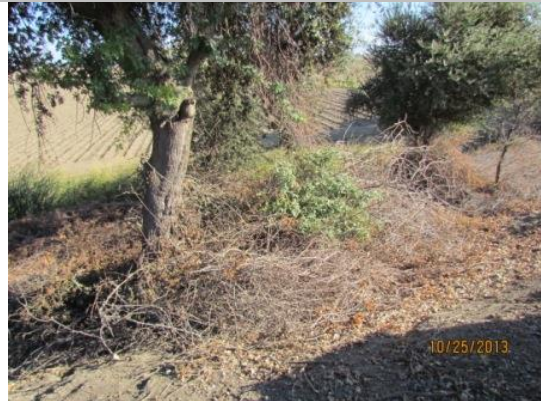
Photo 1 of 1 : FA\_2015\_RD2089\_316\_52\_20150910\_00029.jpg

LM Start	1.43	Rating **	M	Issue No.	52
LM End	1.43	Issue Type +	En	Location *	LS
Category	Earthen Levee			GPS Latitude/Longitude	
				Start	End
Item	Encroachments			37.806378 °	37.806378 °
				-121.406486 °	-121.406486 °
DWR ID	DWR_RD2089_01_f_2013_52				
Action/Comments					
Prunings

View of the tree branches obstructing landside levee slope.

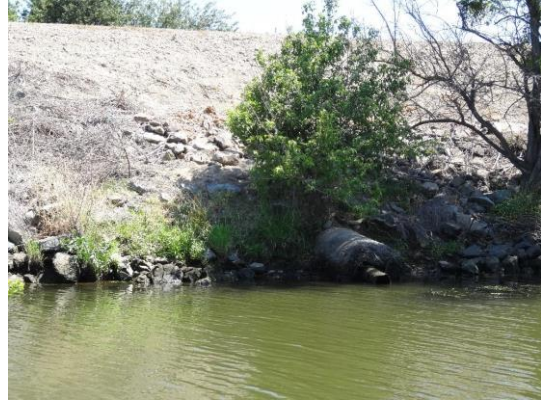
Photo 1 of 2 : UCIP\_FA\_2015\_6036.jpg

View up WS slope from water. Pipe does not cross channel.

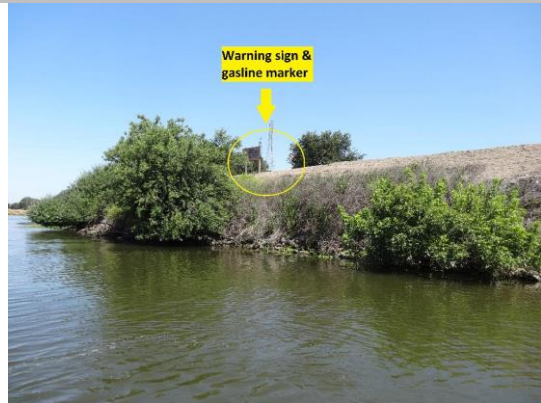
Photo 2 of 2 : UCIP\_FA\_2015\_6037.jpg

Gasline marker (for crossing with DS ID 25121) appr. 100 ft west of crossing.

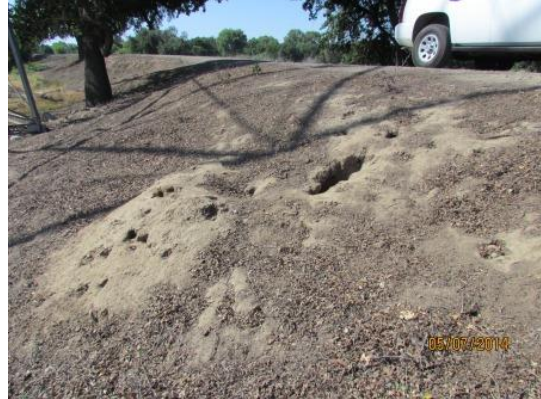
Photo 1 of 1 : FA\_2015\_RD2089\_317\_48\_20150910\_00031.jpg

LM Start	0.16	Rating **	U	Issue No.	48
LM End	0.16	Issue Type +	Ma	Location *	LS
Category	Earthen Levee			GPS Latitude/Longitude	
				Start	End
Item	Animal Control			37.808583 °	37.808583 °
				-121.409432 °	-121.409432 °
DWR ID	DWR_RD2089_02_f_2013_48				
Action/Comments					
No rodents visible, but rodent burrows visible; need to backfill and compact or grout burrows.

View of the rodent burrow on the landside levee slope.

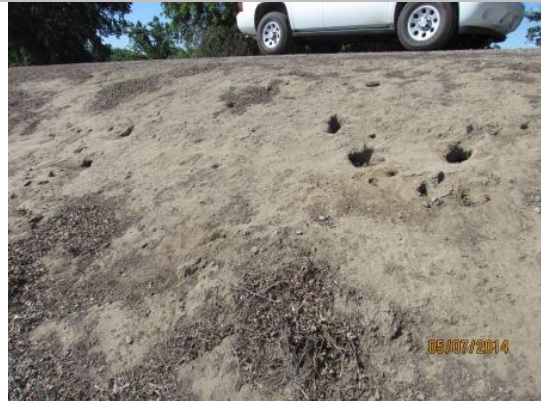
Photo 1 of 1 : FA\_2015\_RD2089\_317\_49\_20150910\_00032.jpg

LM Start	0.21	Rating **	M	Issue No.	49
LM End	0.21	Issue Type +	Ma	Location *	LS
Category	Earthen Levee			GPS Latitude/Longitude	
				Start	End
Item	Animal Control			37.809148 °	37.809148 °
				-121.409897 °	-121.409897 °
DWR ID	DWR_RD2089_02_f_2013_49				
Action/Comments					
No rodents visible, but rodent burrows visible; need to backfill and compact or grout burrows.

View of the multiple rodent burrows on the landside levee hinge and slope.

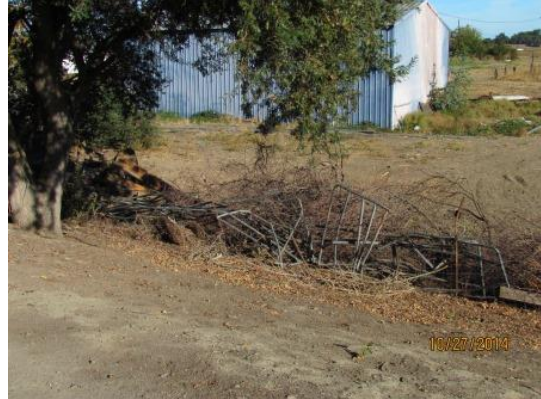
Photo 1 of 1 : FA\_2015\_RD2089\_317\_52\_20150910\_00034.jpg

LM Start	0.28	Rating **	M	Issue No.	52
LM End	0.30	Issue Type +	En	Location *	LS
Category	Earthen Levee			GPS Latitude/Longitude	
				Start	End
Item	Encroachments			37.809899 °	37.809997 °
				-121.410888 °	-121.411298 °
DWR ID	DWR_RD2089_02_f_2013_52				
Action/Comments					
Prunings Inspector Comments: Remove prunings and other debris from the levee toe.

View of the tree branches on the landside levee toe obstructing access.

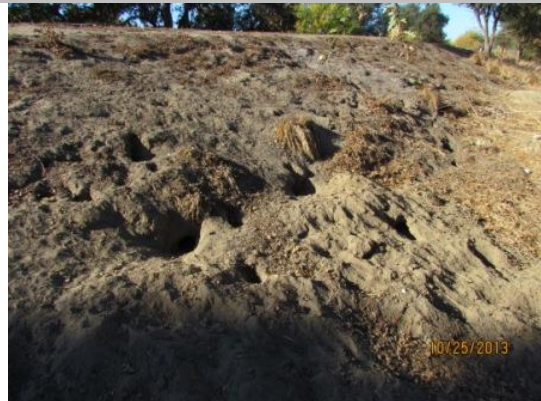
Photo 3 of 3 : FA\_2015\_RD2089\_317\_53\_20150910\_00037.jpg

Another view of the multiple rodent burrows on the landside levee slope.

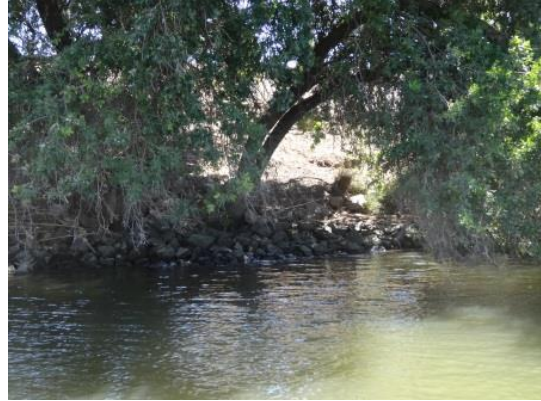
Photo 1 of 2 : SJR2015\_RD2089U02RM28.35\_7.jpg

11/05/2008: Cut into levee profile; riprap slide; rodent holes; pictures do not match GPS and current condition. [2015 Site ID:RD2089U02RM28.35]

View of the site from the survey boat.

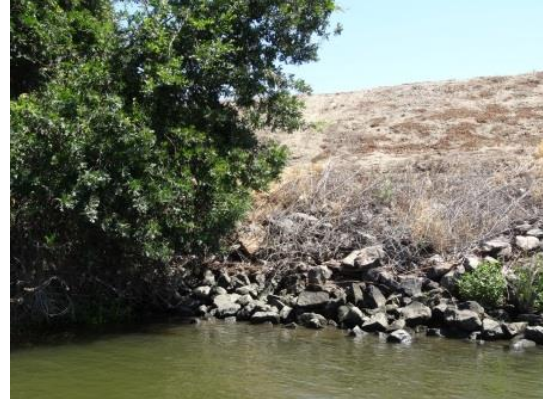
Photo 2 of 2 : SJR2015\_RD2089U02RM28.35\_8.jpg

LM Start	0.40	Rating **	M	Issue No.	1 (cont)	
LM End	0.41	Issue Type +	Ma	Location *	WS	
Category	Supplemental			GPS Latitude/Longitude		
				Start	End	
Item	DWR Erosion Survey			37.809960 °	37.809960 °	
				-121.413200 °	-121.413200 °	
DWR ID						
Action/Comments						
Inspector Comments: 06/25/2015: No significant change observed. 07/02/2014: No significant change observed. 08/13/2013: No significant change observed. 08/07/2012: The site has been visited by boat survey. No significant change observed. 08/23/2011: No significant change observed on site. 09/07/2010: Site consists of a jutting rip rap that has created an eddy, scouring the levee slope. Most sections of the toe and lower slope are lined with rip rap. However, the rip rap is sloughing on the mid slope and at the toe, exposing the underlying soils and tree roots. The remaining revetment is no longer adequately protecting the slope. There are 3 Sycamore trees at the toe with exposed tree roots. 08/05/2010: Recommended for repair, per CLRO. 09/28/2009: Pocket erosion on lower slope just above the toe rip rap; protruding rip rap upstream is creating an eddy, scouring the levee slope; Site # is the same as RM28.40,LM0.30; previously rated "U"; pictures will be made available during the next survey. 11/05/2008: Cut into levee profile; riprap slide; rodent holes; pictures do not match GPS and current condition. [2015 Site ID:RD2089U02RM28.35]

View of the site from the survey boat.

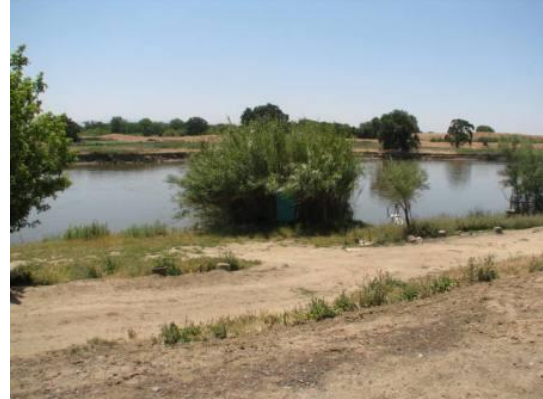
Photo 1 of 1 : FA\_2015\_RD2089\_317\_27\_20150910\_00025.jpg

LM Start	0.44	Rating **	M	Issue No.	27
LM End	0.44	Issue Type +	En	Location *	WS
Category	Earthen Levee			GPS Latitude/Longitude	
				Start	End
Item	Encroachments			37.810490 °	37.810490
				-121.413638 °	-121.413638
DWR ID	DWR_RD2089_02_s _ 2012_27				
Action/Comments					
Building					
Inspector Comments: Portable toilet on bank, at water's edge.

05/24/2011 Portable toilet is in the shadows in the center of the photo at the water's edge.

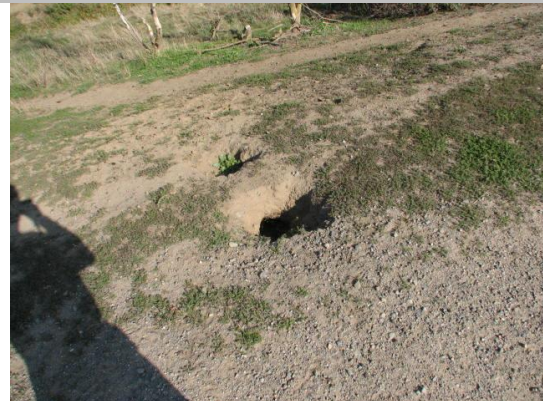
Photo 1 of 1 : FA\_2015\_RD2089\_317\_13\_20150910\_00015.jpg

LM Start	0.46	Rating **	M	Issue No.	13
LM End	0.46	Issue Type +	Ma	Location *	CR
Category	Earthen Levee			GPS Latitude/Longitude	
				Start	End
Item	Animal Control			37.810691 °	37.810691 °
				-121.414014 °	-121.414014 °
DWR ID	DWR_RD2089_02_s _ 2012_13				
Action/Comments					
No rodents visible, but rodent burrows visible; need to backfill and compact or grout burrows.					
Inspector Comments: Two old burrows that need to be filled.

11/10/2011 Two large burrows on crown, need to be filled.

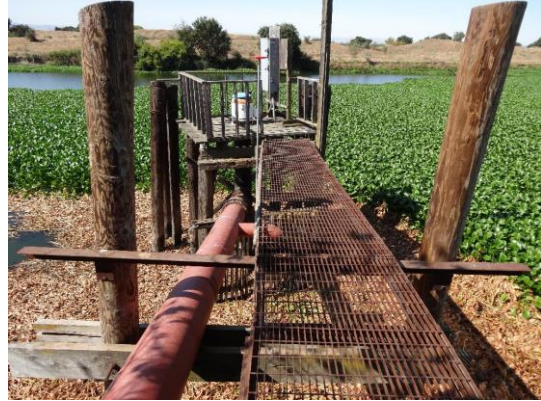
Photo 1 of 3 : UCIP\_FA\_2015\_0721.jpg

Action/Comments					
Inspector Comments: FS_ID:21676 DS_ID:23047 EP_NO: N/A FS_HLM: 0.555 Repair Type: Non-Urgent Crossing Status: Found UCIP Comments: - air relief valve on waterside. Needs repair.- concrete standpipe on landside. FIELD_STRUCT_DESC: 14-inch pipe through the levee, 8.0 feet below the crown, pump on pile structure in the stream. Air relief valve on the waterside slope. Timber walkway to the pump. Concrete distribution standpipe on landside toe. Originally included in O+M (1968) FS Date: 09/12/2013

WS view: pipe (left) and steel walkway to pump on piling structure in the channel.

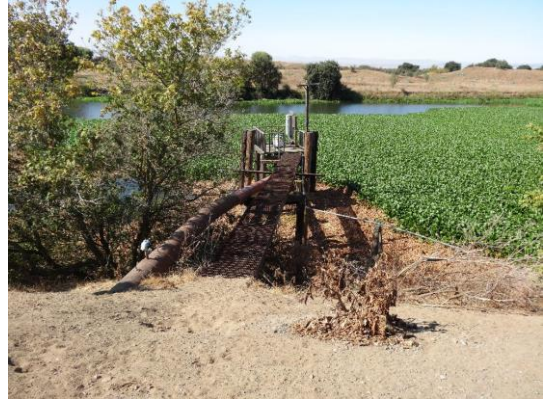
Photo 3 of 3 : UCIP\_FA\_2015\_0723.jpg

LM Start	0.54	Rating **	M	Issue No.	58 (cont)
LM End	0.54	Issue Type +	En	Location *	WS
Category	Supplemental			GPS Latitude/Longitude	
				Start	End
Item	DWR UCIP Field Study			37.811369 °	37.811369 °
				-121.415050 °	-121.415050 °
DWR ID					
Action/Comments					
Inspector Comments: FS_ID:21676					
DS_ID:23047					
EP_NO: N/A					
FS_HLM: 0.555					
Repair Type: Non-Urgent					
Crossing Status: Found

WS view: pipe and pump on piling structure in water channel.

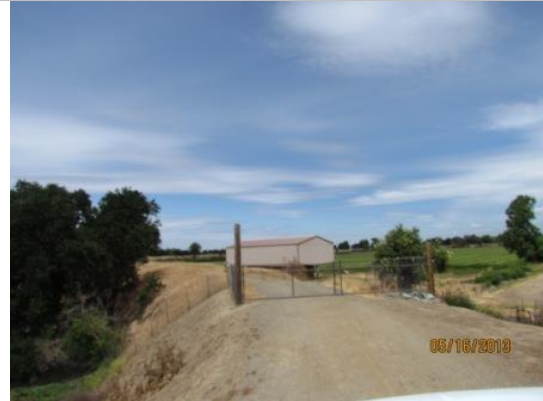
Photo 1 of 1 : FA\_2015\_RD2089\_317\_9\_20150910\_00010.jpg

LM Start	0.84	Rating **	A/W	Issue No.	9
LM End	0.84	Issue Type +	En	Location *	CR
Category	Earthen Levee			GPS Latitude/Longitude	
				Start	End
Item	Encroachments			37.814881 °	37.814881 °
				-121.414676 °	-121.414676 °
DWR ID	DWR_RD2089_02_s _ 2012_9				
Action/Comments					
Fence					
Inspector Comments: Gate across levee crown.

View of the fence gate across levee crown.

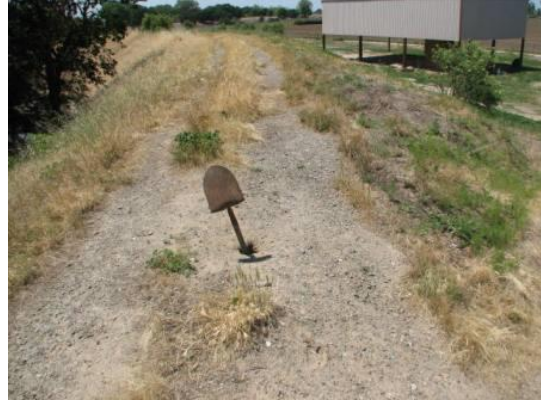
Photo 2 of 3 : FA\_2015\_RD2089\_317\_40\_20150910\_00029.jpg

LM Start	0.85	Rating **	U	Issue No.	40 (cont)
LM End	0.90	Issue Type +	Ma	Location *	LS
Category	Earthen Levee			GPS Latitude/Longitude	
				Start	End
Item	Animal Control			37.814997 °	37.814970 °
				-121.414774 °	-121.415767 °
DWR ID	DWR_RD2089_02_s _ 2012_40				
Action/Comments					
Exterminate rodents and backfill and compact or grout burrows. Inspector Comments: Numerous burrows on landside slope adjacent to hay storage area. Deep burrows in crown and landside ramp.

05/24/2011 Deep vertical burrow in levee crown.

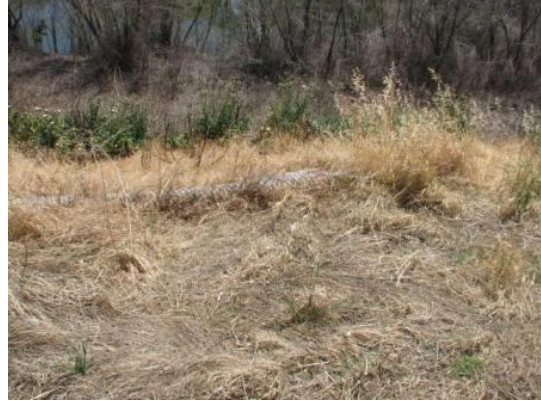
Photo 1 of 1 : FA\_2015\_RD2089\_317\_41\_20150910\_00030.jpg

LM Start	0.94	Rating **	M	Issue No.	41
LM End	0.94	Issue Type +	Ma	Location *	WS
Category	Earthen Levee			GPS Latitude/Longitude	
				Start	End
Item	Encroachments			37.814940 °	37.814940 °
				-121.416499 °	-121.416499 °
DWR ID	DWR_RD2089_02_s_2012_41				
Action/Comments					
Pipe					
Inspector Comments: Debris/CMP on levee slope needs to be removed.

05/24/2011 Old CMP left on waterside levee slope, needs to be removed.

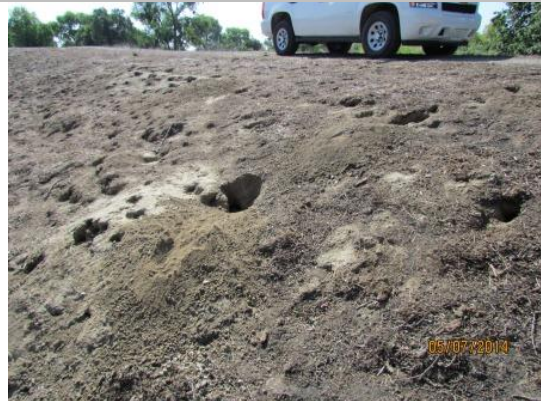
Photo 1 of 1 : FA\_2015\_RD2089\_317\_5\_20150910\_00005.jpg

LM Start	0.95	Rating **	U	Issue No.	5
LM End	0.95	Issue Type +	Ma	Location *	LS
Category	Earthen Levee			GPS Latitude/Longitude	
				Start	End
Item	Animal Control			37.814915 °	37.814915 °
				-121.416606 °	-121.416606 °
DWR ID	DWR_RD2089_02_s_2014_5				
Action/Comments					
Exterminate rodents and backfill and compact or grout burrows.

View of the rodent holes on the landside levee slope.

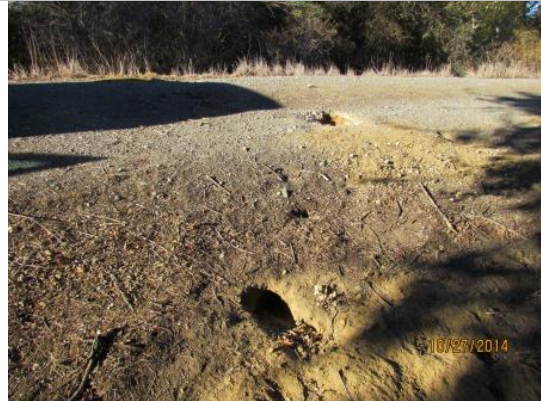
Photo 2 of 2 : FA\_2015\_RD2089\_317\_12\_20150910\_00014.jpg

LM Start	1.00	Rating **	U	Issue No.	12 (cont)	
LM End	1.00	Issue Type +	Ma	Location *	CR	
Category	Earthen Levee			GPS Latitude/Longitude		
				Start	End	
Item	Animal Control			37.815182 °	37.815182	
				-121.417439 °	-121.417439	
DWR ID	DWR_RD2089_02_f_2014_12					
Action/Comments						
No rodents visible, but rodent burrows visible; need to backfill and compact or grout burrows.

View of several rodent burrows on landside levee hinge and crown.

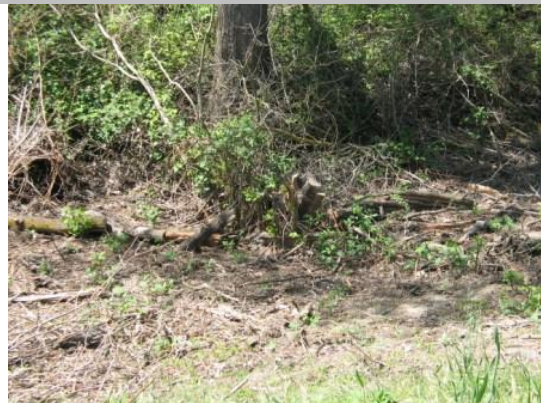
Photo 1 of 1 : FA\_2015\_RD2089\_317\_29\_20150910\_00026.jpg

LM Start	1.05	Rating **	N	Issue No.	29
LM End	1.05	Issue Type +	Ma	Location *	WS
Category	Earthen Levee			GPS Latitude/Longitude	
				Start	End
Item	Trim / Thin Trees			37.815629 °	37.815629
				-121.418133 °	-121.418133
DWR ID	DWR_RD2089_02_s_2012_29				
Action/Comments					
Tree stumps. Inspector Comments: 14" dia stump. Could not verify as the area is overgrown with high weeds.

Tree stump &gt;2" left after vegetation and tree removal.

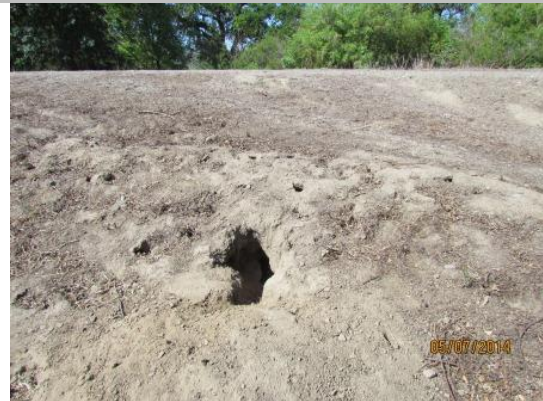
Photo 1 of 1 : FA\_2015\_RD2089\_317\_6\_20150910\_00006.jpg

LM Start	1.18	Rating **	M	Issue No.	6
LM End	1.18	Issue Type +	Ma	Location *	LS
Category	Earthen Levee			GPS Latitude/Longitude	
				Start	End
Item	Animal Control			37.817271 °	37.817271 °
				-121.419380 °	-121.419380 °
DWR ID	DWR_RD2089_02_s _ 2014_6				
Action/Comments					
Exterminate rodents and backfill and compact or grout burrows.

View of the large rodent hole on the landside levee slope.

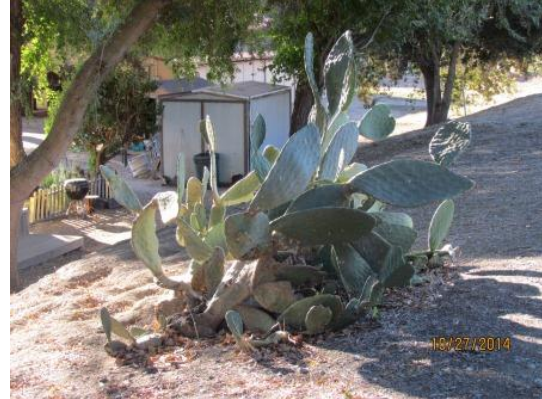
Photo 1 of 1 : FA\_2015\_RD2089\_317\_57\_20150910\_00039.jpg

LM Start	1.27	Rating **	M	Issue No.	57
LM End	1.27	Issue Type +	En	Location *	CR
Category	Earthen Levee			GPS Latitude/Longitude	
				Start	End
Item	Vegetation			37.818499 °	37.818499 °
				-121.419754 °	-121.419754 °
DWR ID	DWR_RD2089_02_f_2013_57				
Action/Comments					
Landscaping					
Inspector Comments: Remove cactus from levee crown.

View of the cactus on the landside levee shoulder.
